Maryland Historical Trust
State Historic Sites Inventory Form

Survey No. WA-III-094

historic Stone house

18854 Sandy Hook Road

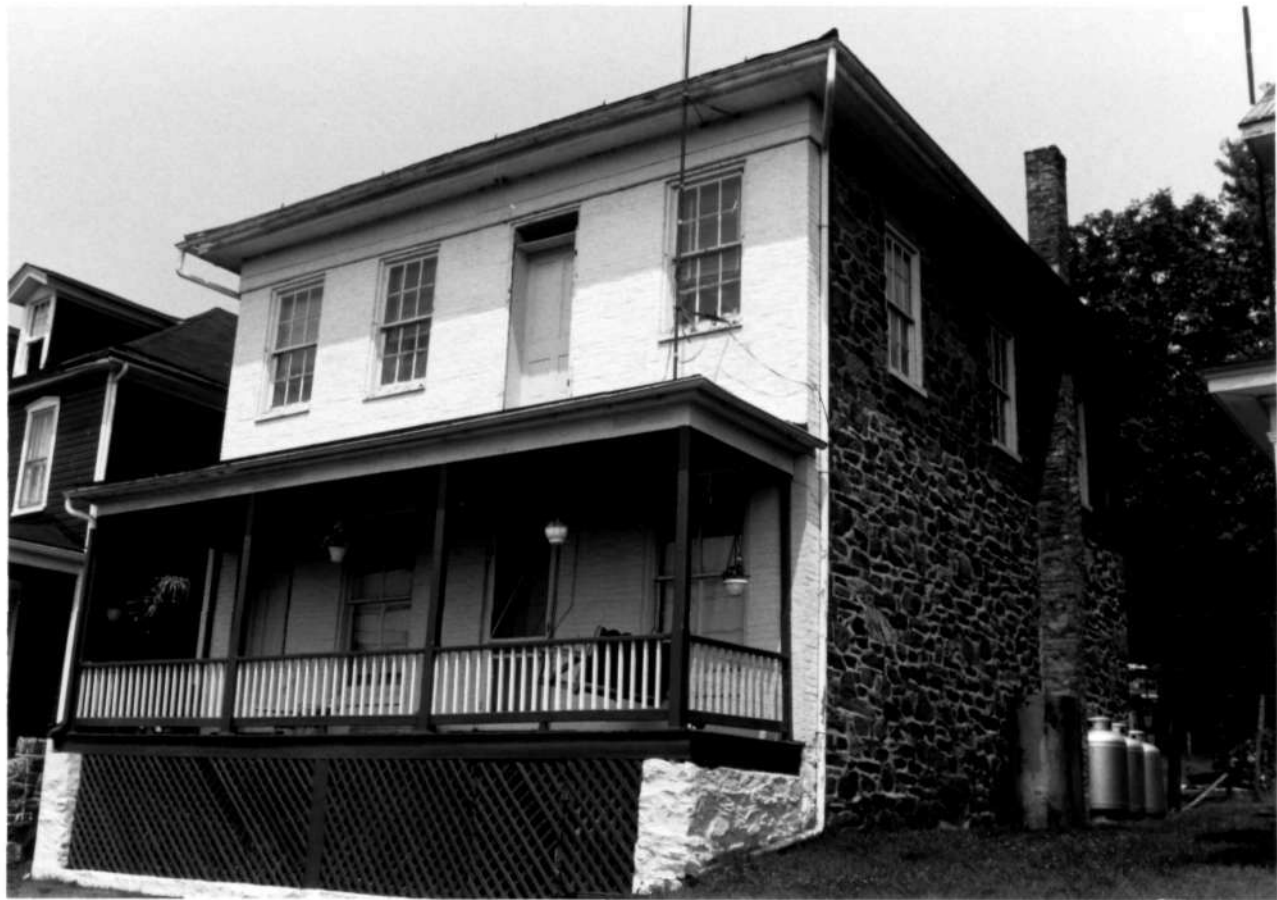
1. WA-III-094
2. Washington Co., Md.
3. Joe Getty
4. ~~April 1983~~ 7/82
5. Md. Hist. Trust, Annapolis, Md.
6. South elev. (camera facing north)
7. 1/1

The stone house is a two-story stone structure with a main facade constructed of brick. The structure is built in a square plan. It is four-bays by three-bays and has a full-length, one-story front porch. The main facade is asymmetrically arranged. It has entrances in the first and third bays from the west on the main story and in the third bays from the west on the second story. Other bays on the first story have large two-over-two sash windows. The other three bays on the second story of the main facade and the three bays on the second story of each end have six-over-six sash windows. The structure has a hipped roof.

The two-story structure has a main facade of brick laid in stretcher bond. The rear of the walls of the structure are rough-laid fieldstone. The full-length, one-story front porch sits on a high fieldstone foundation with lattice-work under the porch. The porch has a hipped roof supported by chamfered posts with a stick railing. The first story has four paneled doors with two-pane transoms in the front and the third bays from the west. The other two bays have large two-over-two sash windows of a commercial style. The second story has a four-paned door with transom in the third bay from the west. Six-over-six sash windows are located on the other bays. The structure has a large boxed cornice with plane frieze. The first story of the sides of the house is unfenestrated. On the second story six-over-six sash windows are located in each bay. The east facade has a exterior-end brick flue.
